# Vintage BMW took years and \$550,000 to restore

*1930s racer gets new lease on life*

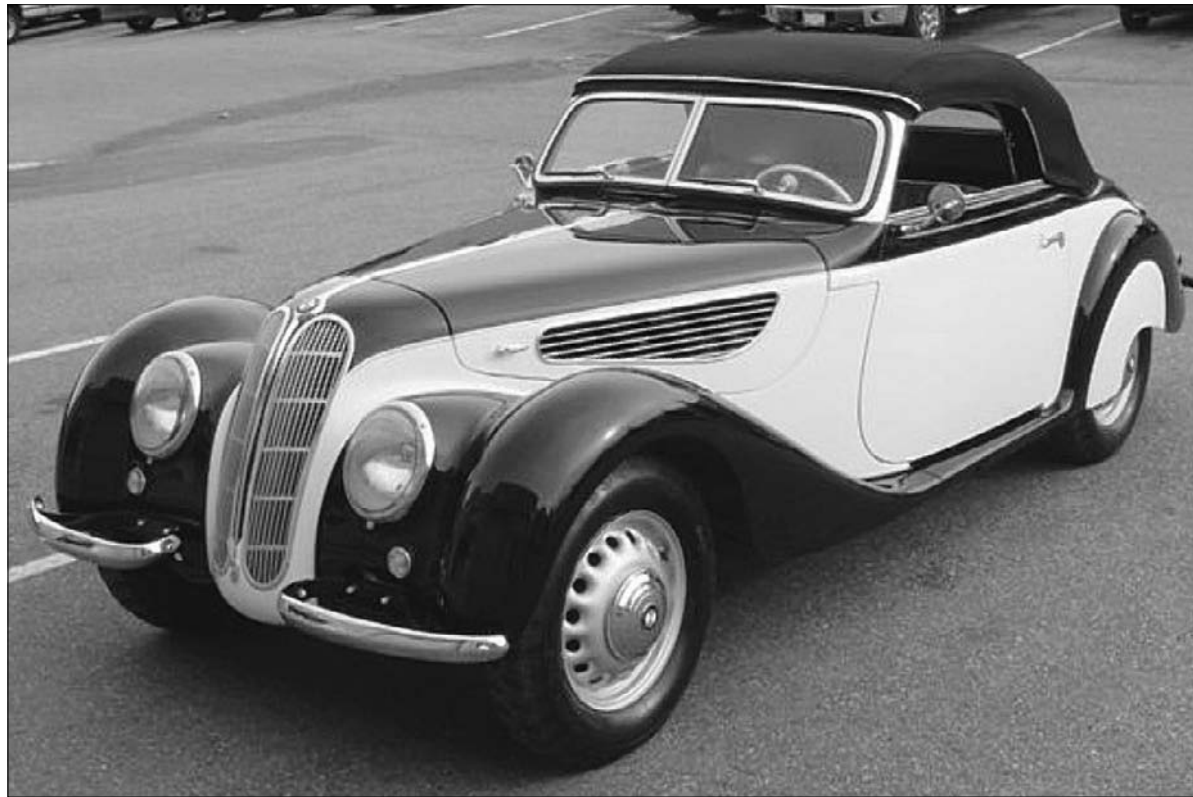
A party was held at Jellybean AutoCrafters in Surrey, B.C., to unveil this restored 1938 BMW 327/28 sports cabriolet.

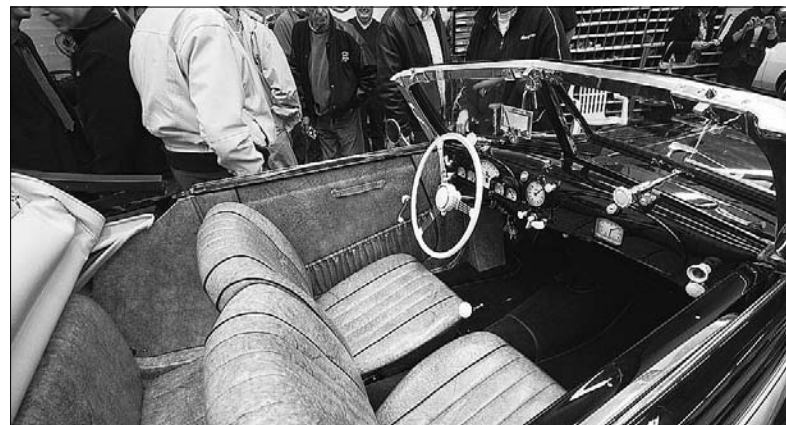
The interior of the 1938 BMW cabriolet has been restored using an exact copy of the upholstery material originally used

"We even used modern gauges and made them look like the originals," Jellybean's Kurt Penner says.

A Volvo four-speed transmission with electric overdrive has been installed, all electrics have been changed from six to 12 volts and modern headlights have been added. The original Bakelite dash knobs have been reproduced in aluminum.

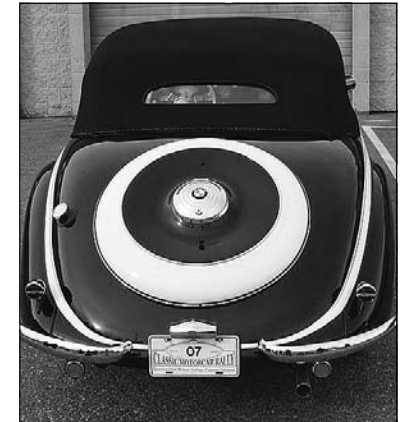
The BMW 327/28 cabriolet is a low-slung, lightweight convertible built between 1937 and 1941.

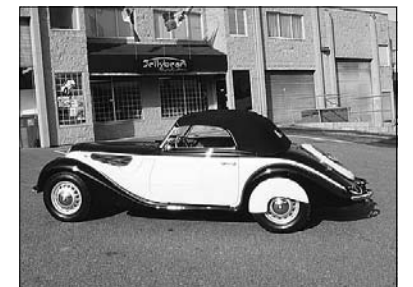
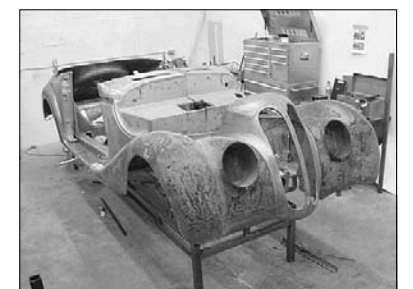
The 1938 BMW cabriolet body as the restoration progressed at Jellybean AutoCrafters

So out came all the wood and the "metal meisters" did their magic, replacing all the wooden structural parts with steel, remanufacturing much of the car. This included fabricating the fenders and running boards and handforming a new aluminum hood.
